BUREAU OF YARDS AND DOCKS WASHINGTON D C

AEC-WT-91

Since protective construction is a problem common to civil as well as military installations, practical methods of design and analysis for blast loadings must be developed for use by structural engineers. The method of design and analysis used in Project 3.2 was developed for practical use by A. Amirikian, Consultant on Special Structures for the Bureau. The complete postshot analysis for two of the most important structures may be found in Chap. 7. The remaining structures will be analyzed as time permits.

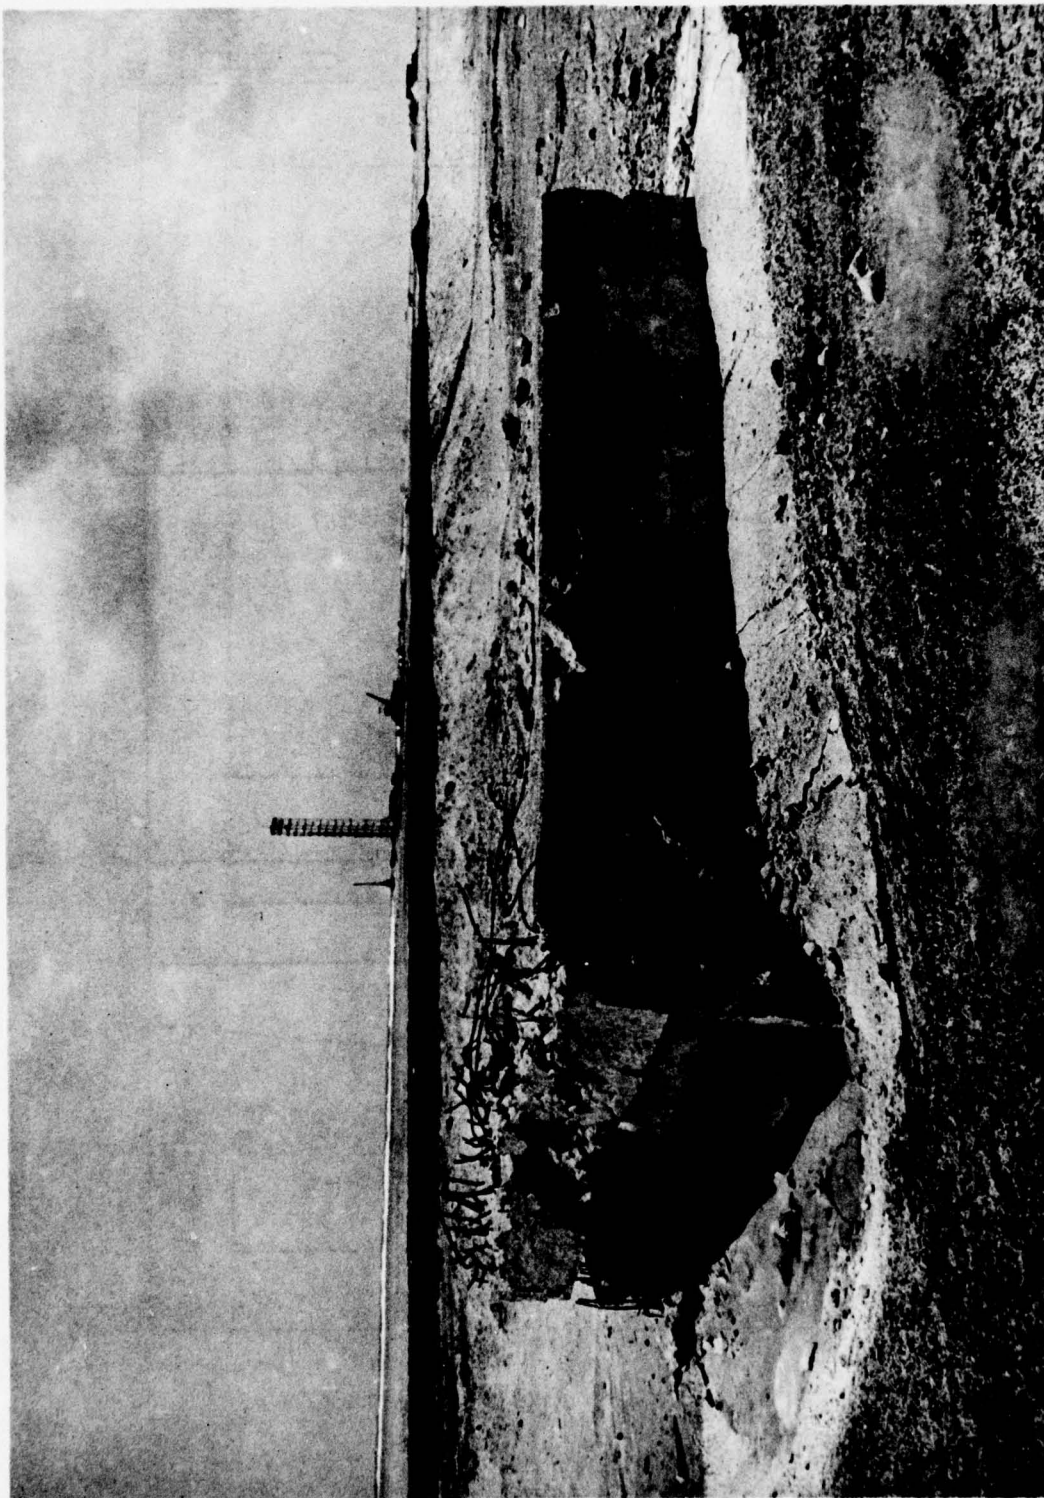
Fig. 6.18 Cracks on Edge of Slab from Right Front, Structure 3.2.1a

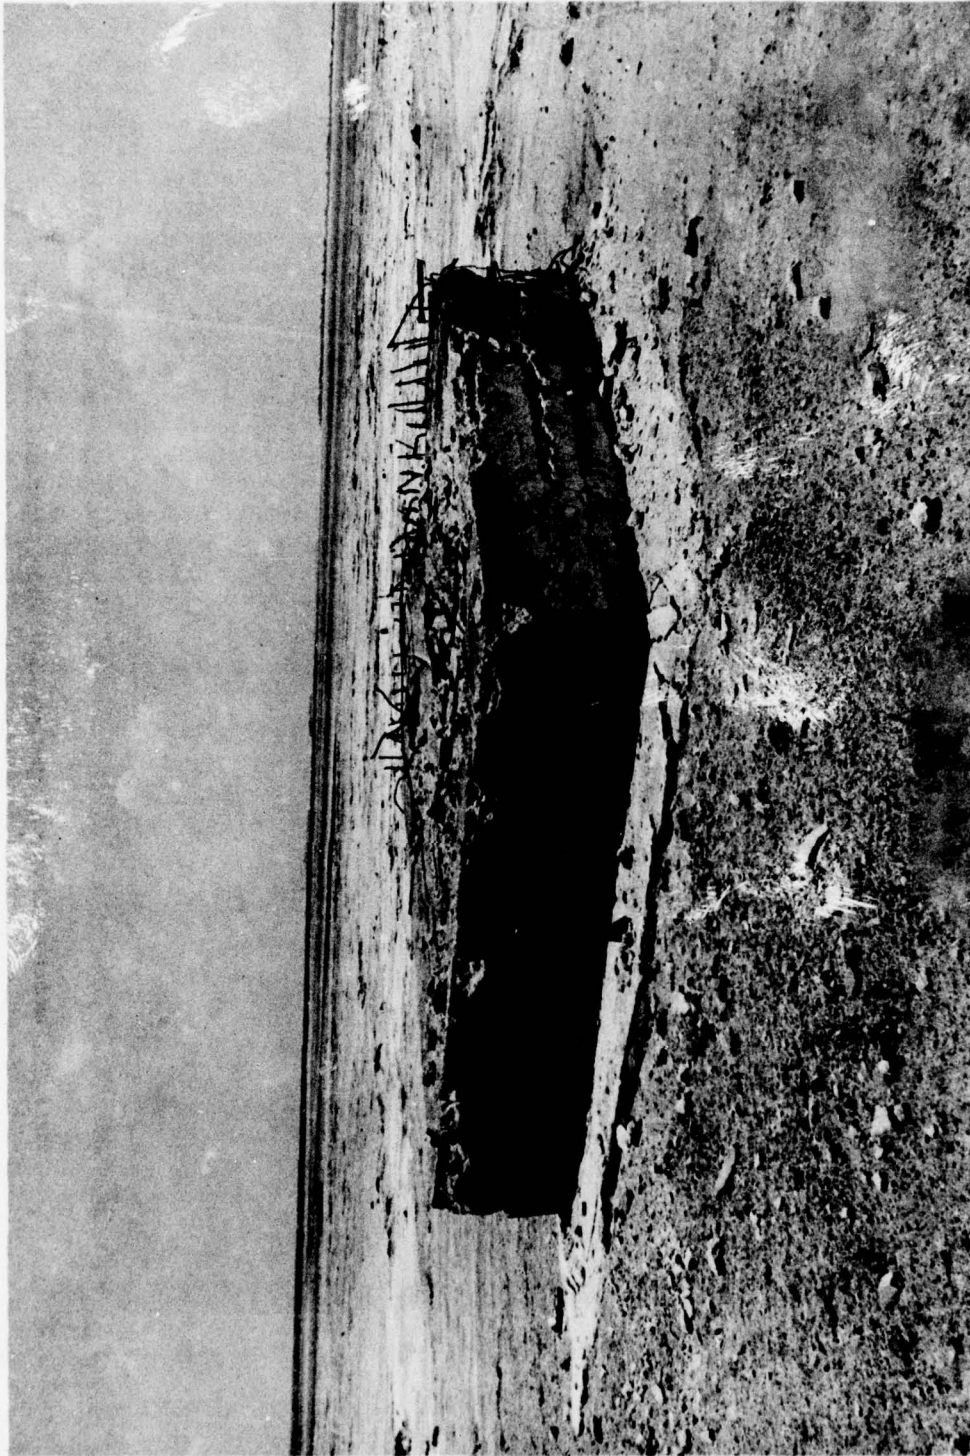
Fig. 6.19 Cracks on Edge of Slab from Left Rear, Structure 3.2.1a

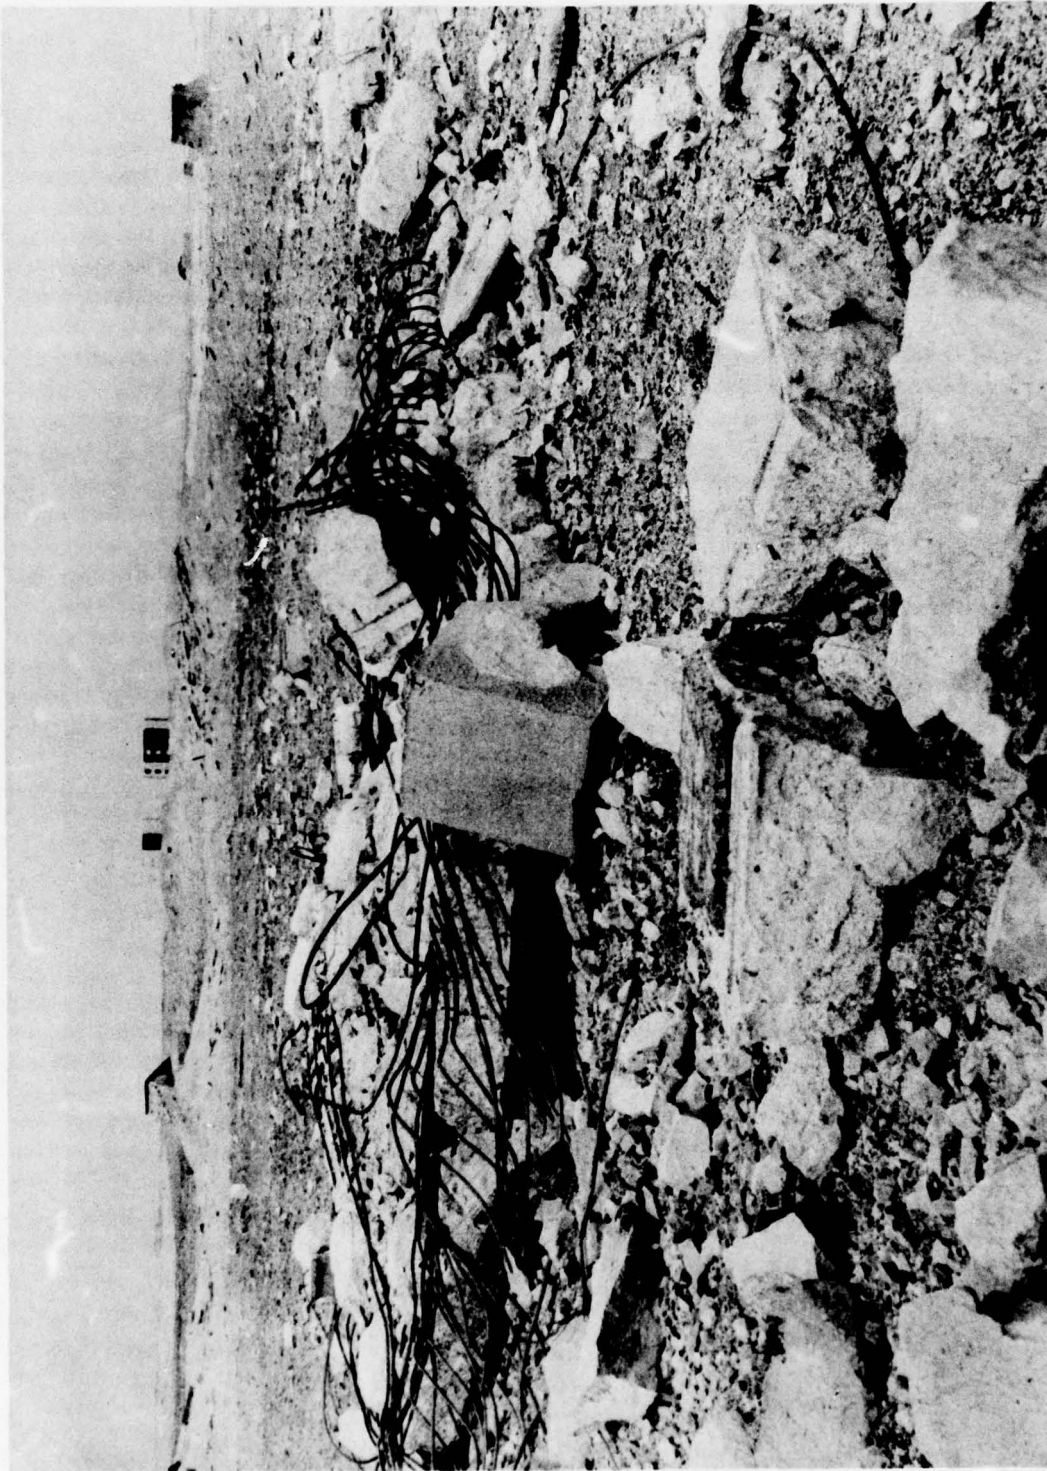
Fig. 6.22 Top Slab Displaced 150 Ft to Rear, Structure 3.2.1b

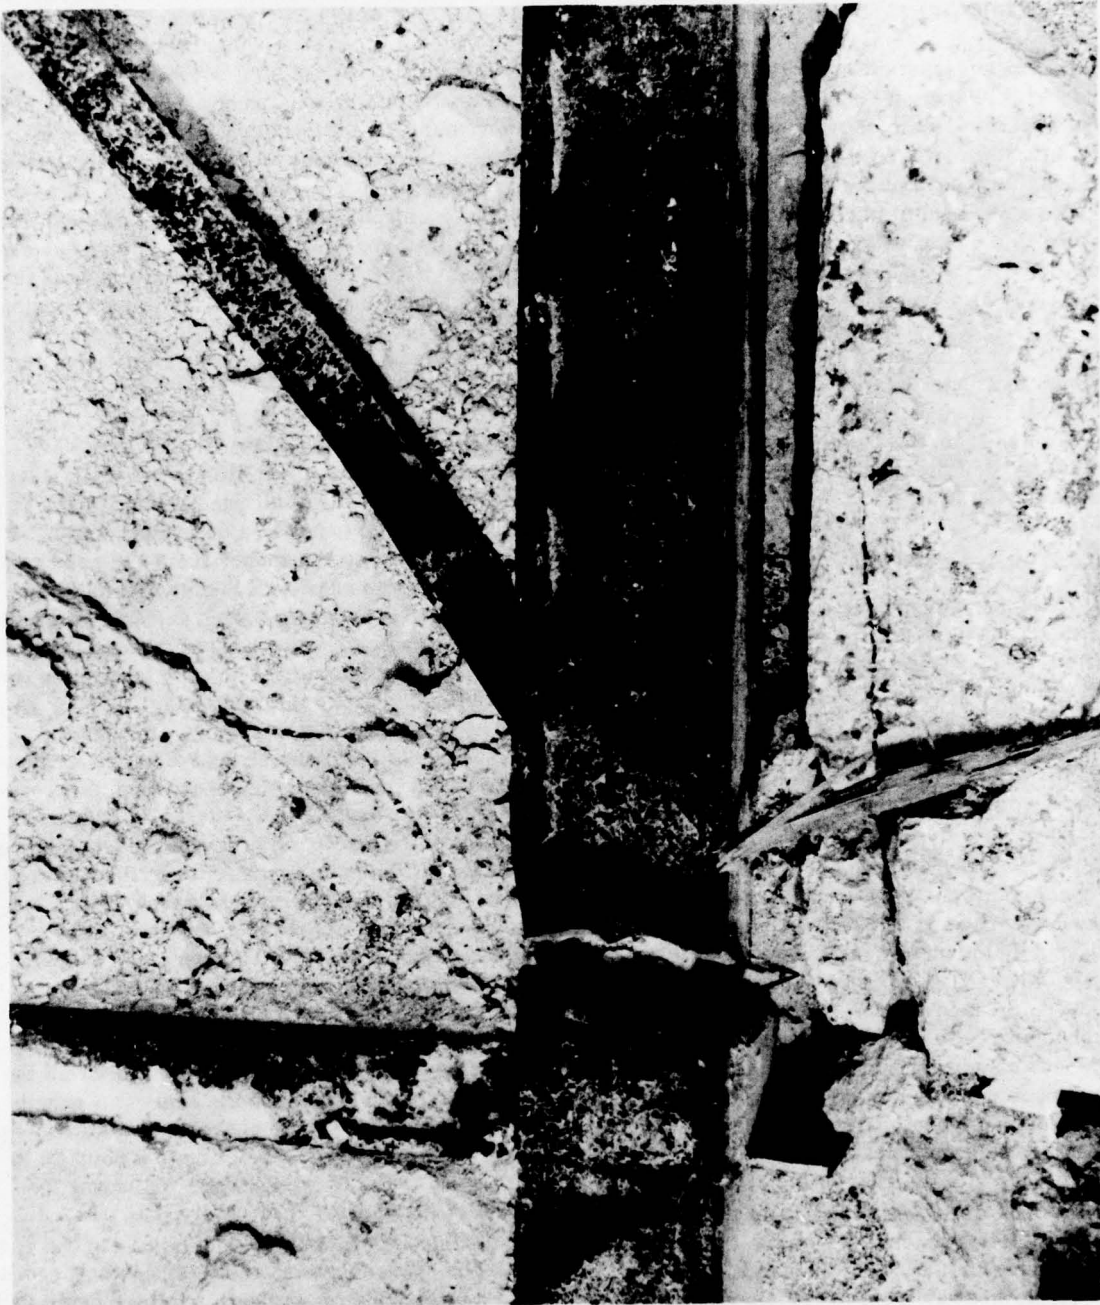
Fig. 6.23 Failure of Weld Between Roof and Bearing Wall, Structure 3.2.1b

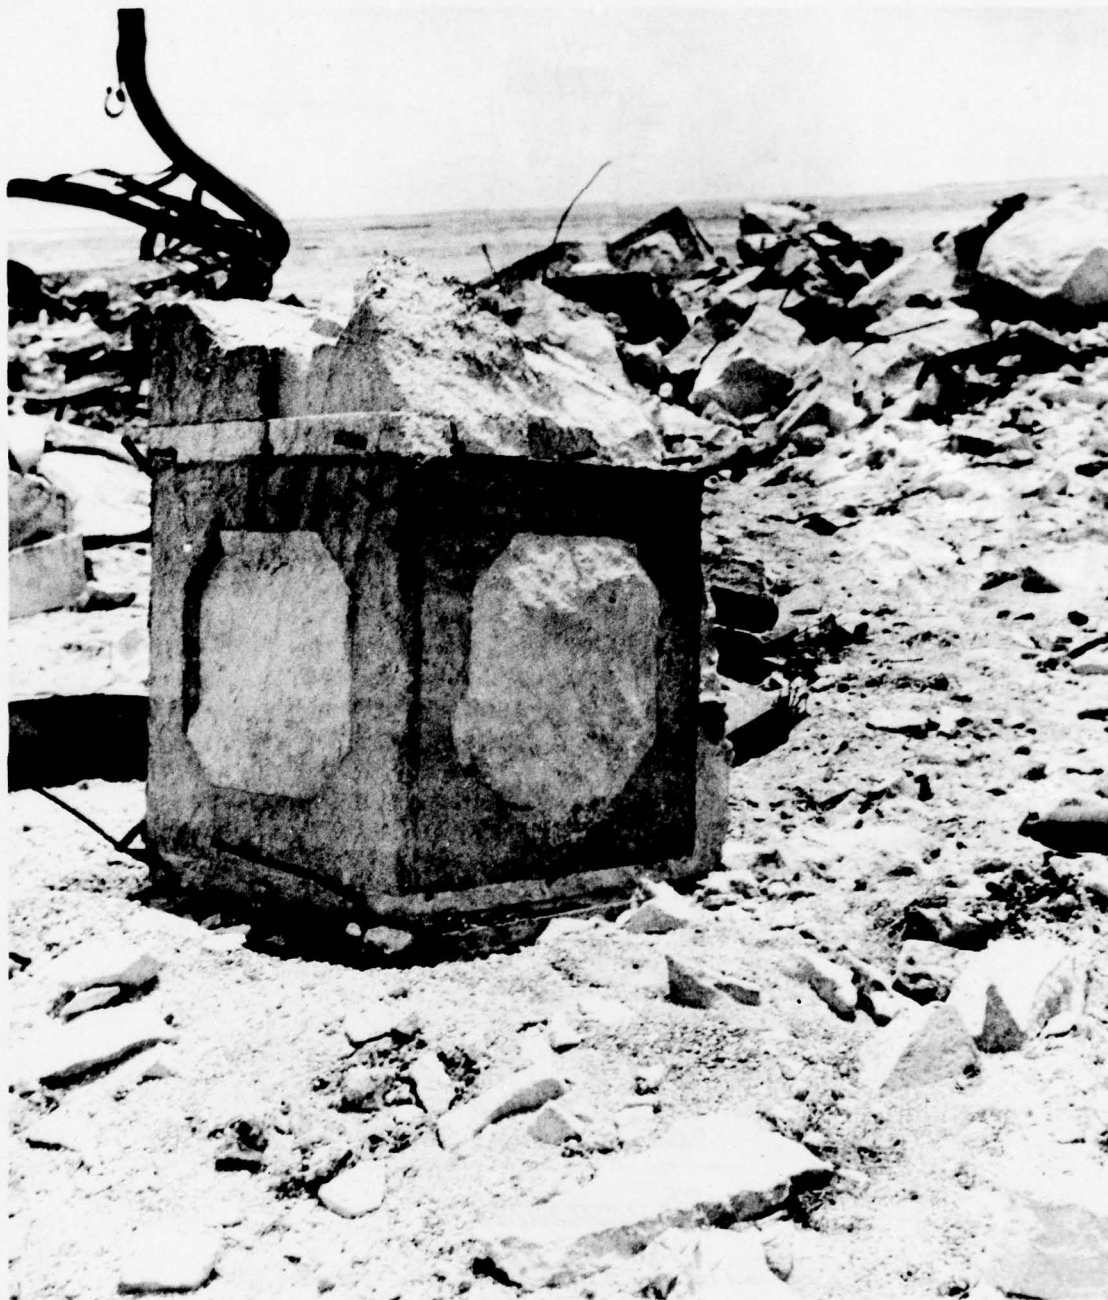
Fig. 6.24 Filled Cell Broken Away from Roof, Structure 3.2.1b

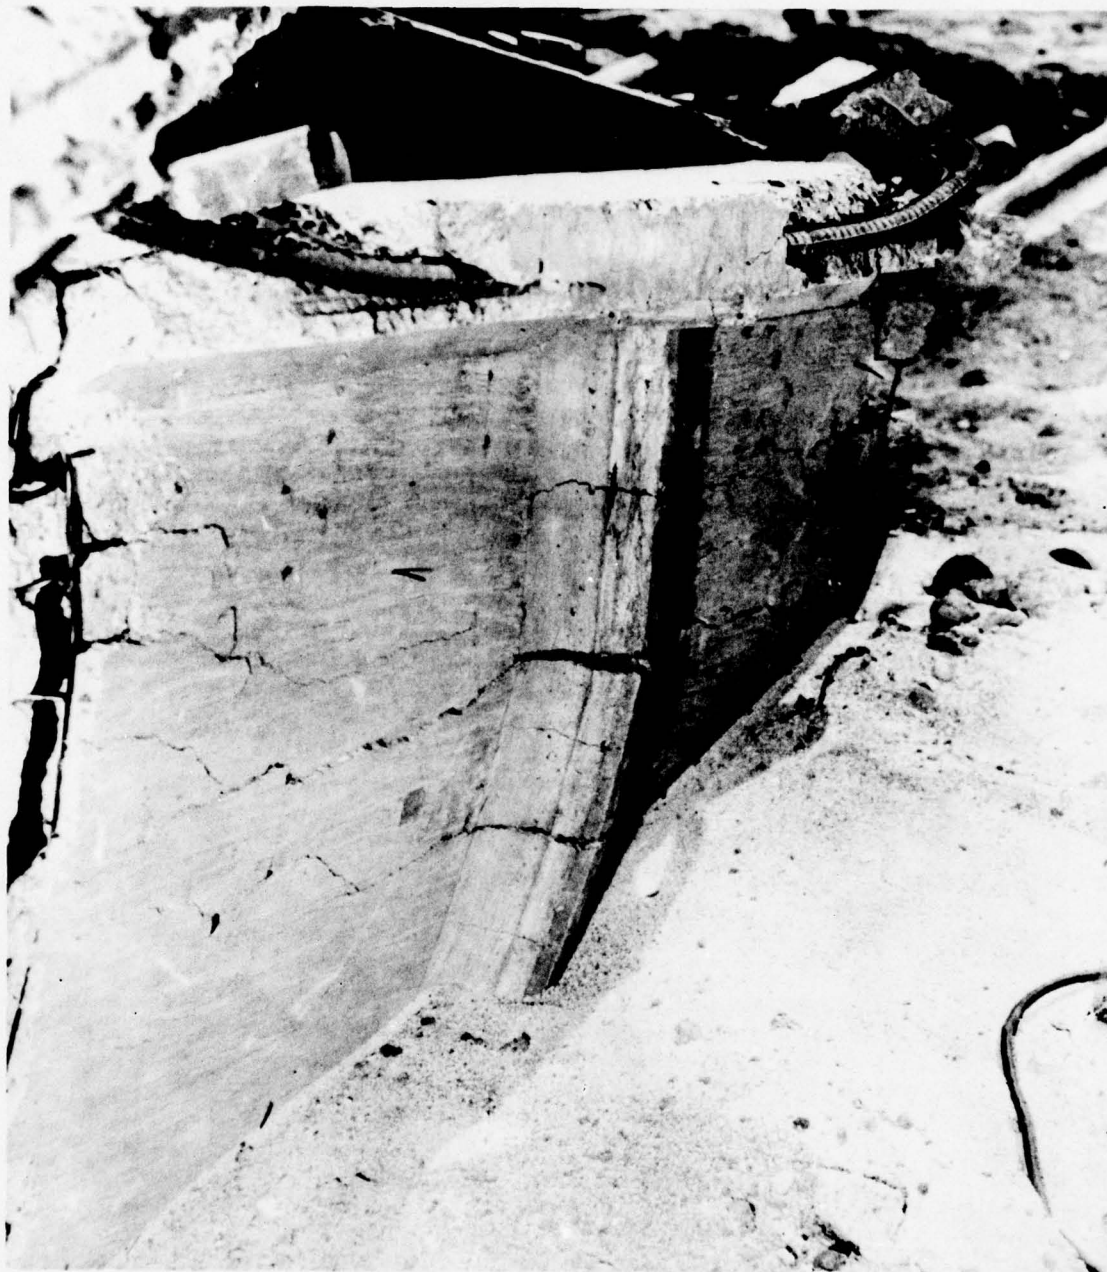
Fig. 6.28 Inward Deformation of Front Panel, Structure 3.2.2a

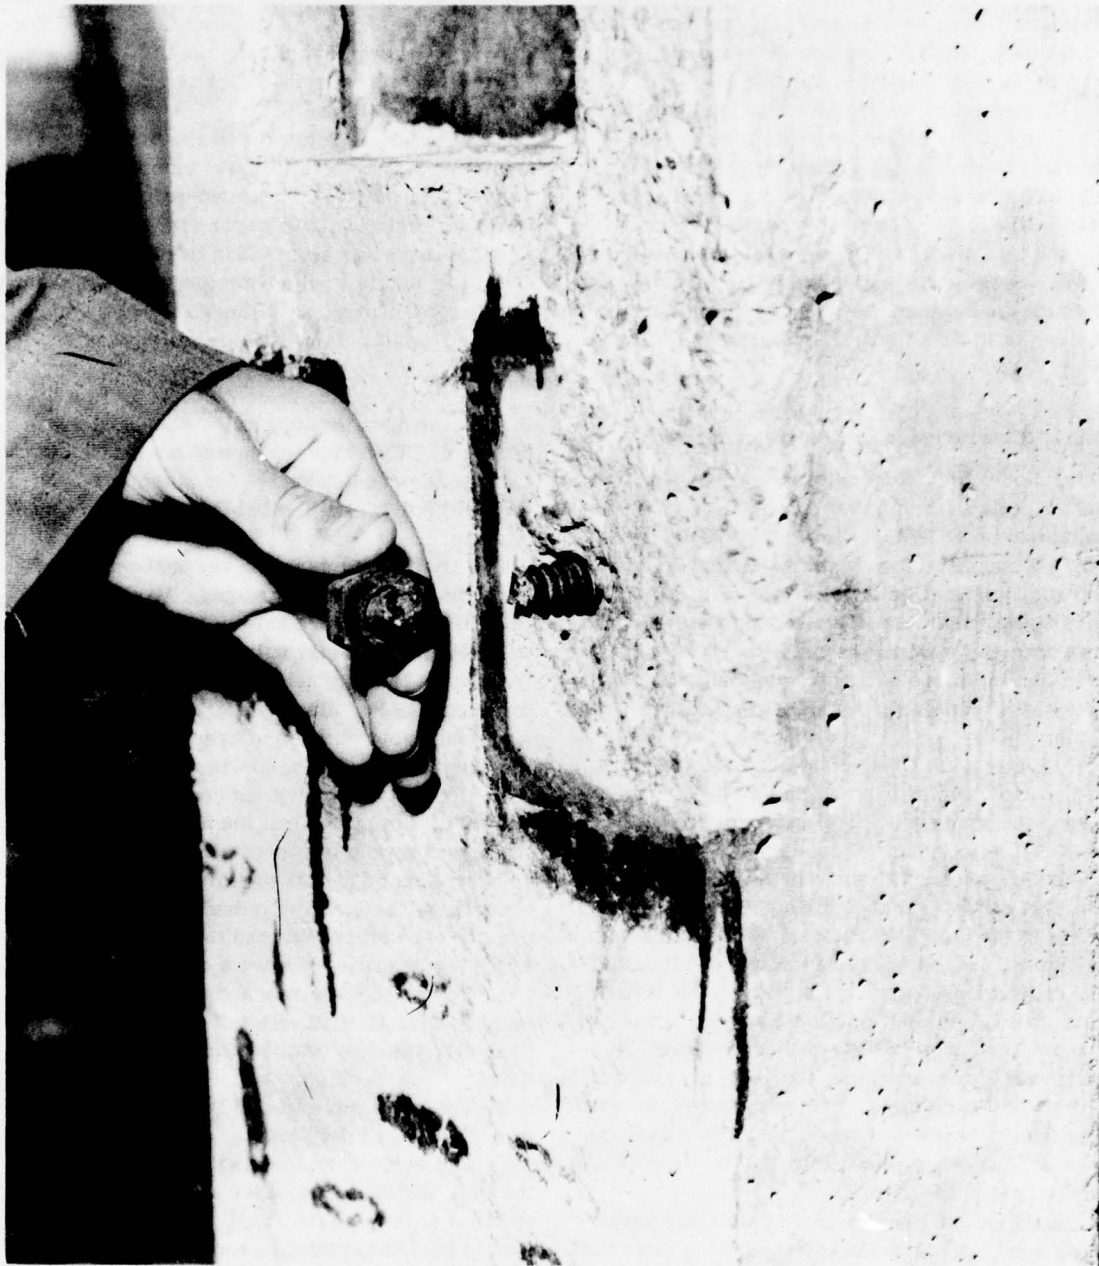
Fig. 6.30 Panel-bolt Failure in Right Bent at Front of Structure 3.2.2a

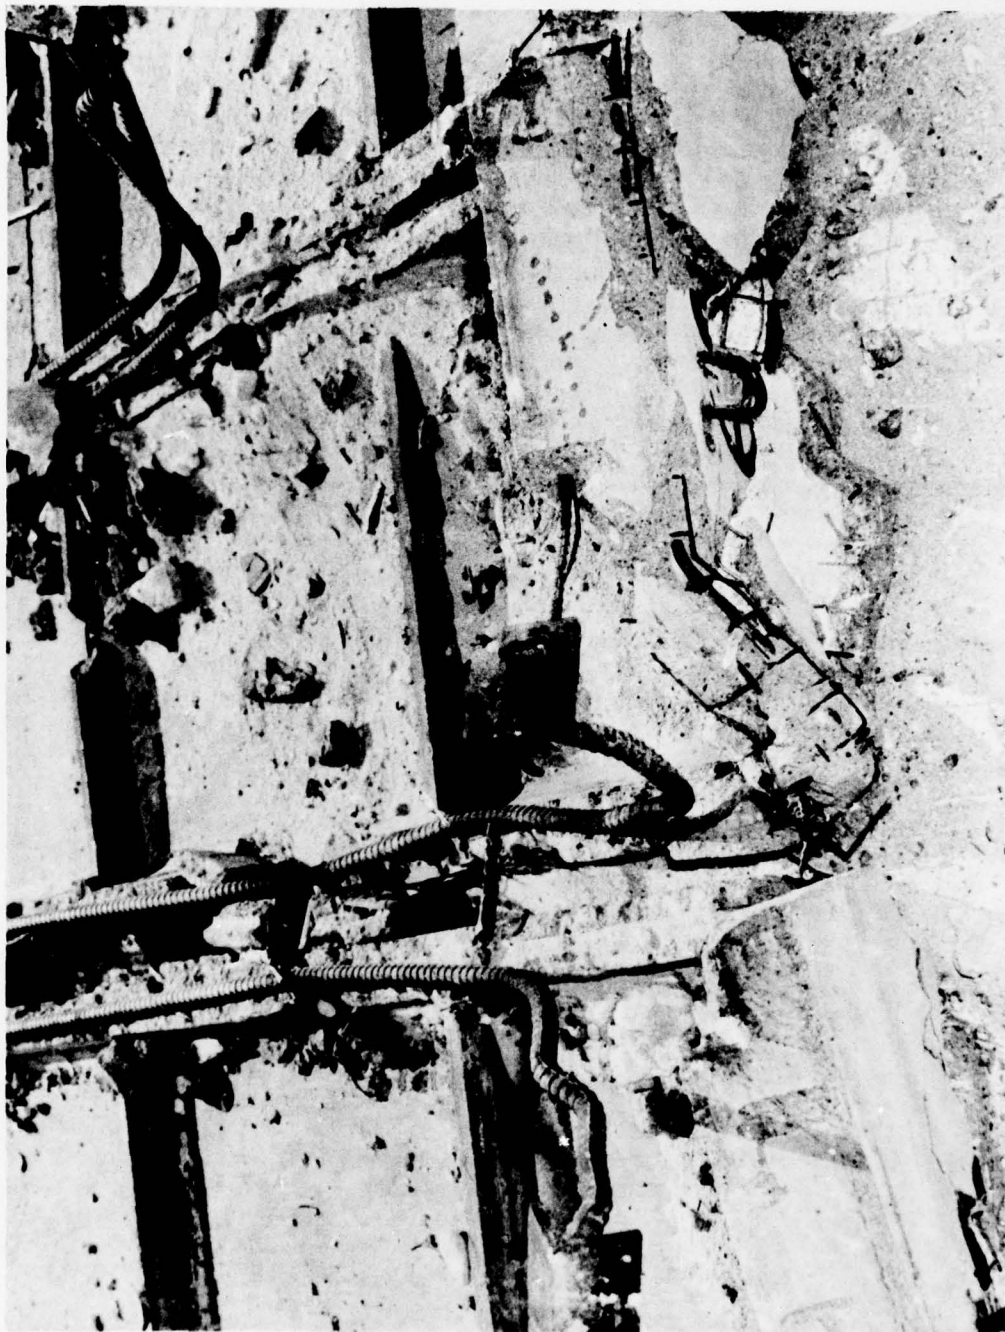
Fig. 6.32 Weld Failure Between Roof and Wall Panel, Structure 3.2.2a

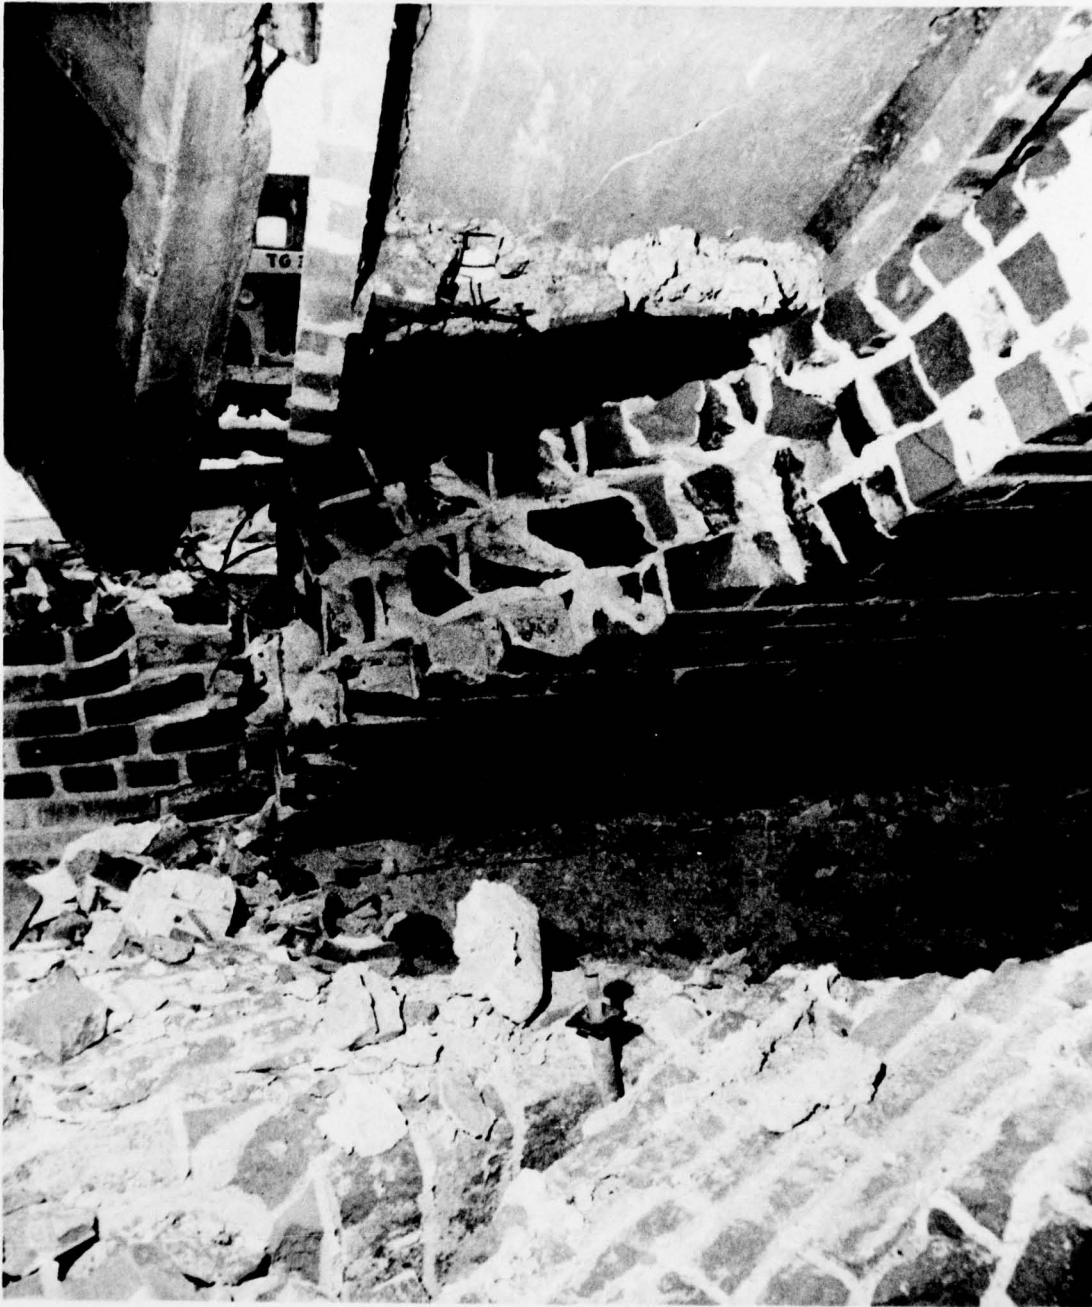
Fig. 6.36 Typical Masonry Failures Through Brick, Structure 3.2.2b

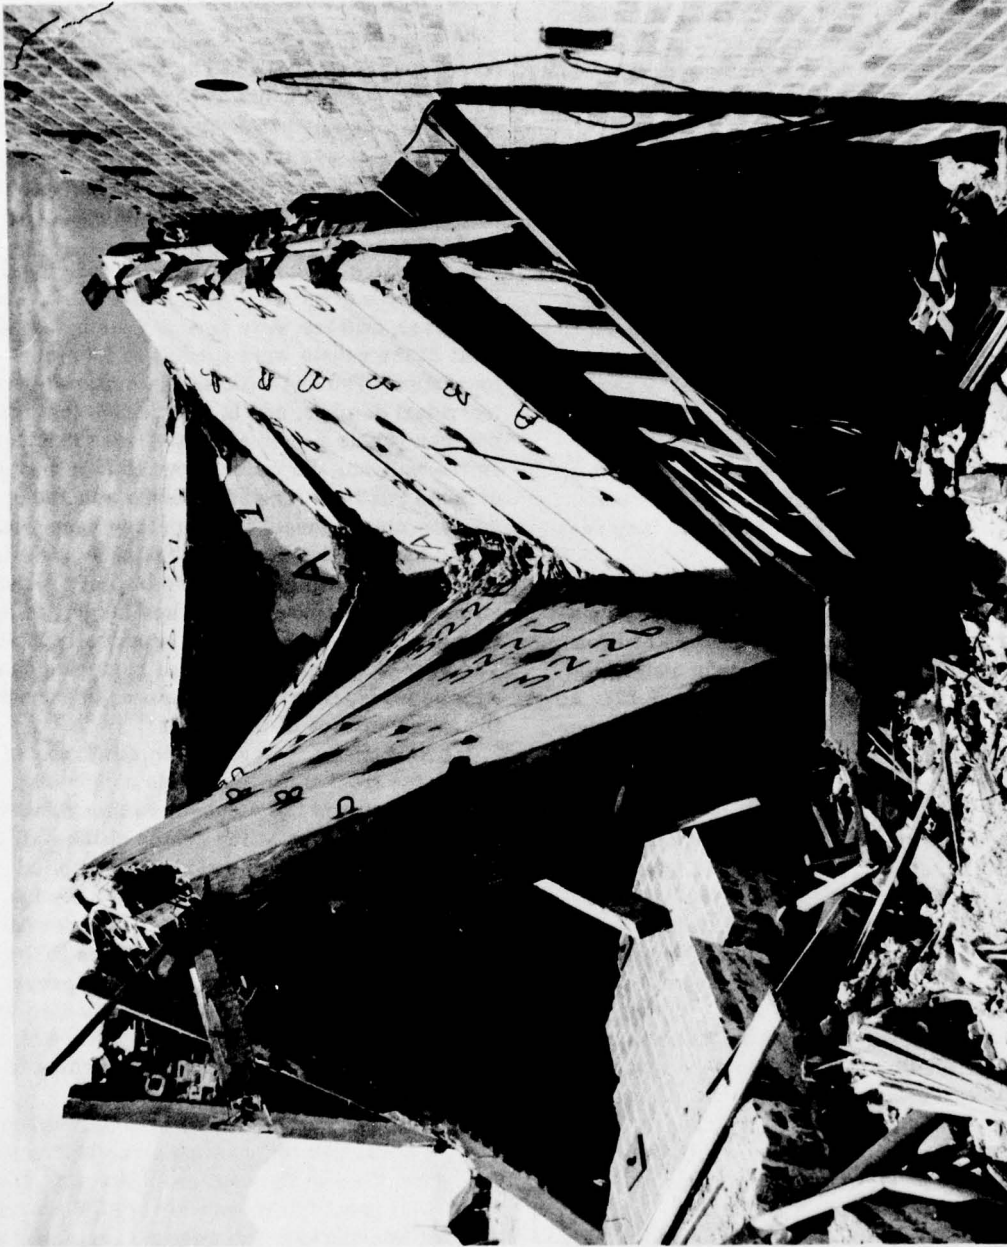
Fig. 6.37 Left Half of Roof Showing Column Type Failure, Structure 3.2.2b

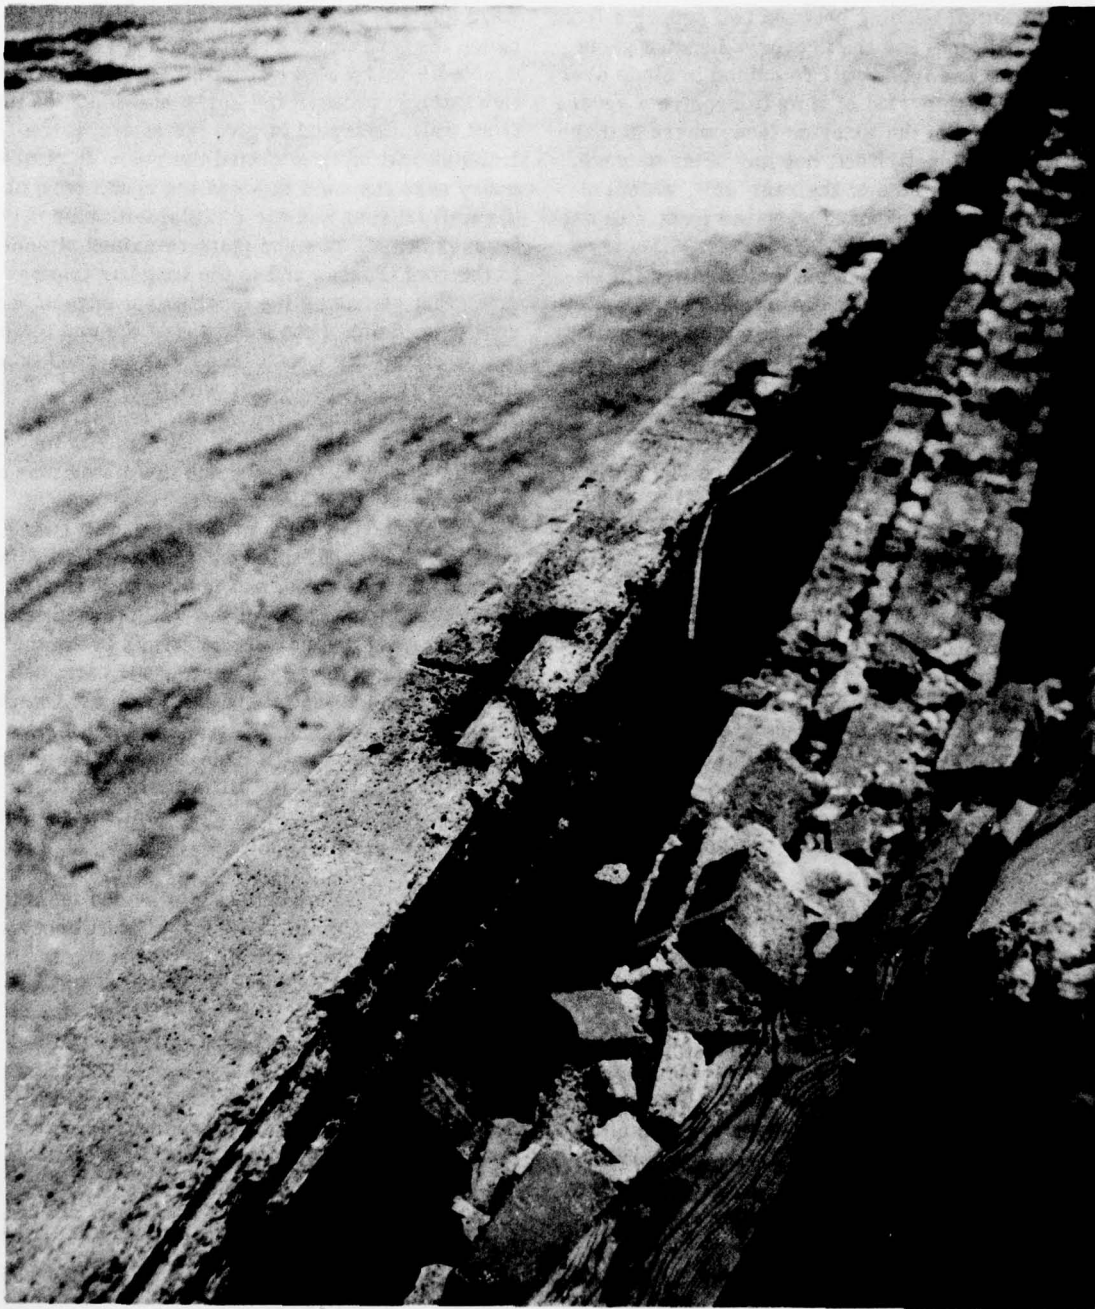
Fig. 6.38 Weld Failures Between Roof and Wall Panels, Structure 3.2.2b

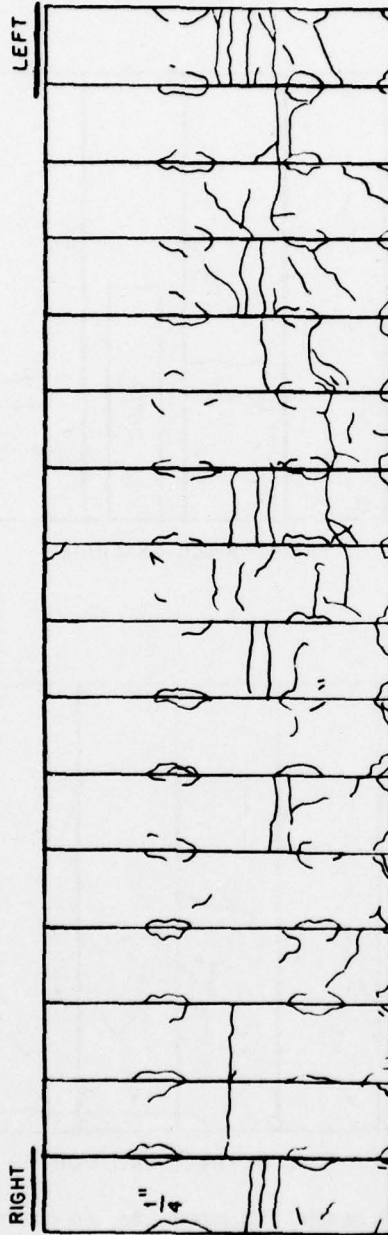
Fig. 6.41 Rear-wall Crack Pattern, Structure 3.2.2b

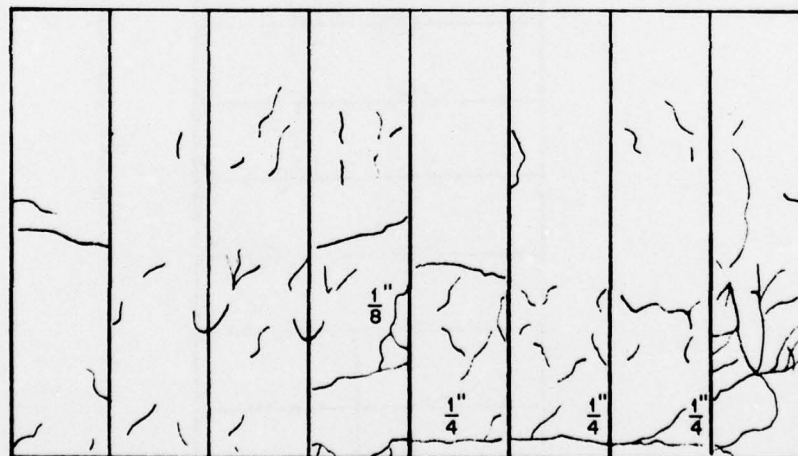
Fig. 6.42 End-wall Crack Pattern, Structure 3.2.2b. All cracks are hairline except as noted.

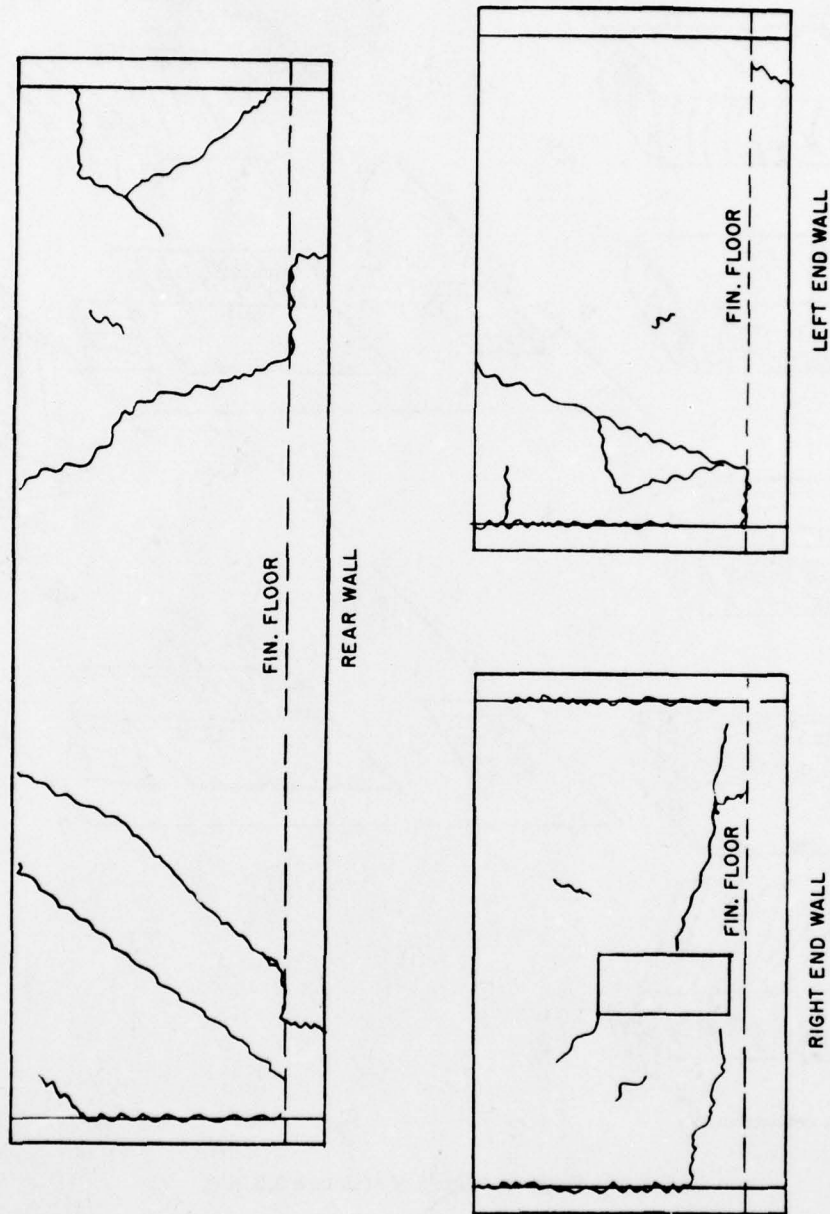
Fig. 6.43 Cracks on Interior of Brick Wall, Structure 3.2.2b

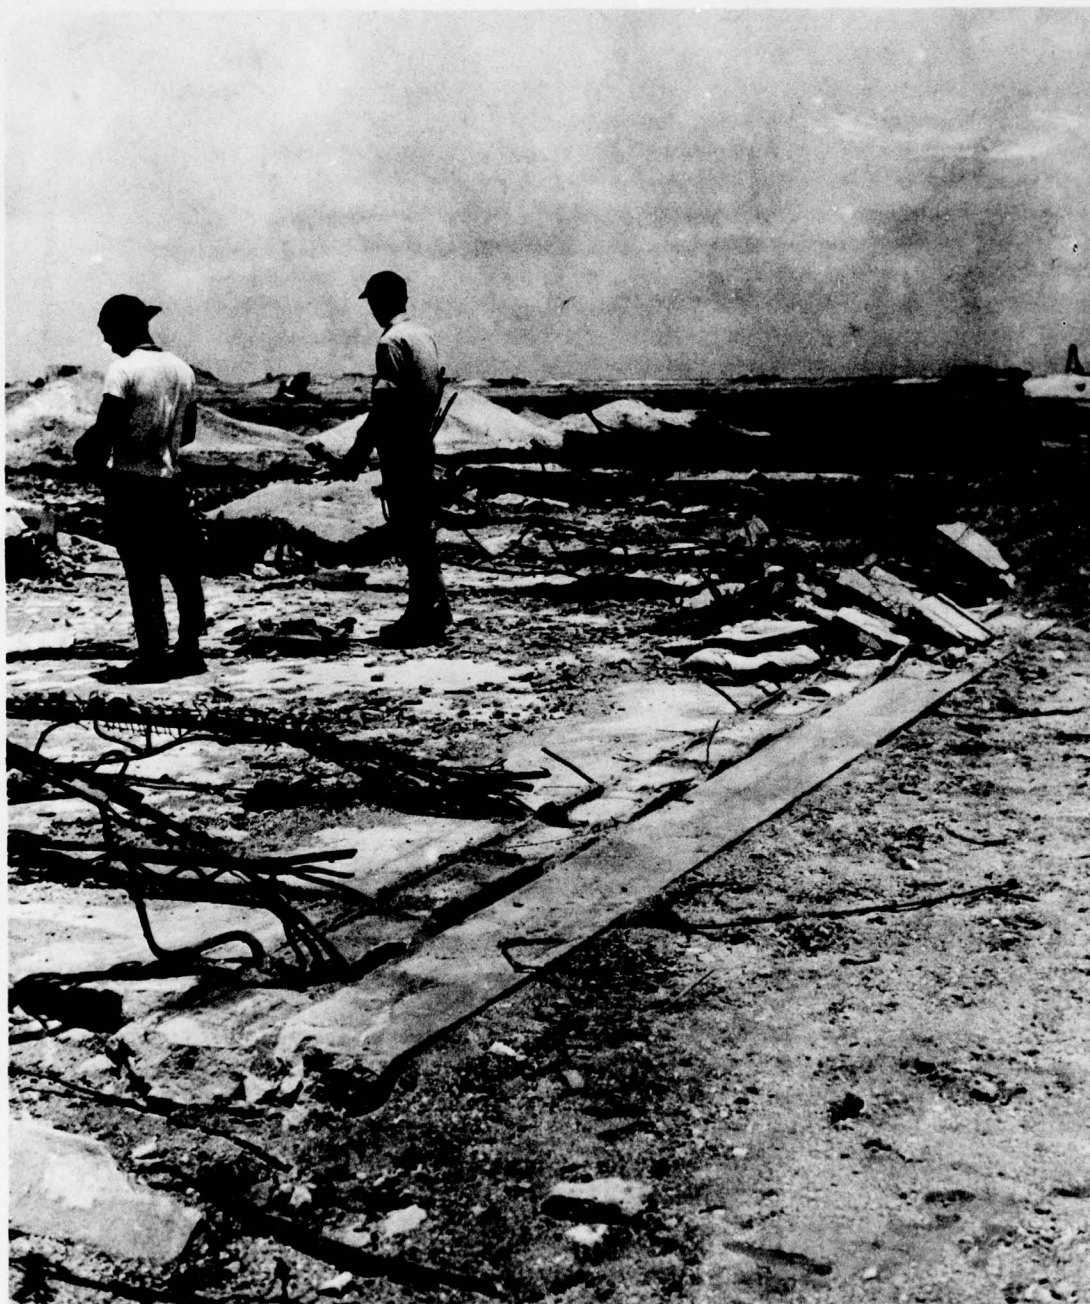
Fig. 6.46 View Along Front Edge of Foundation of Structure 3.2.3a. Isolated trusses are only remnants of Front Wall.

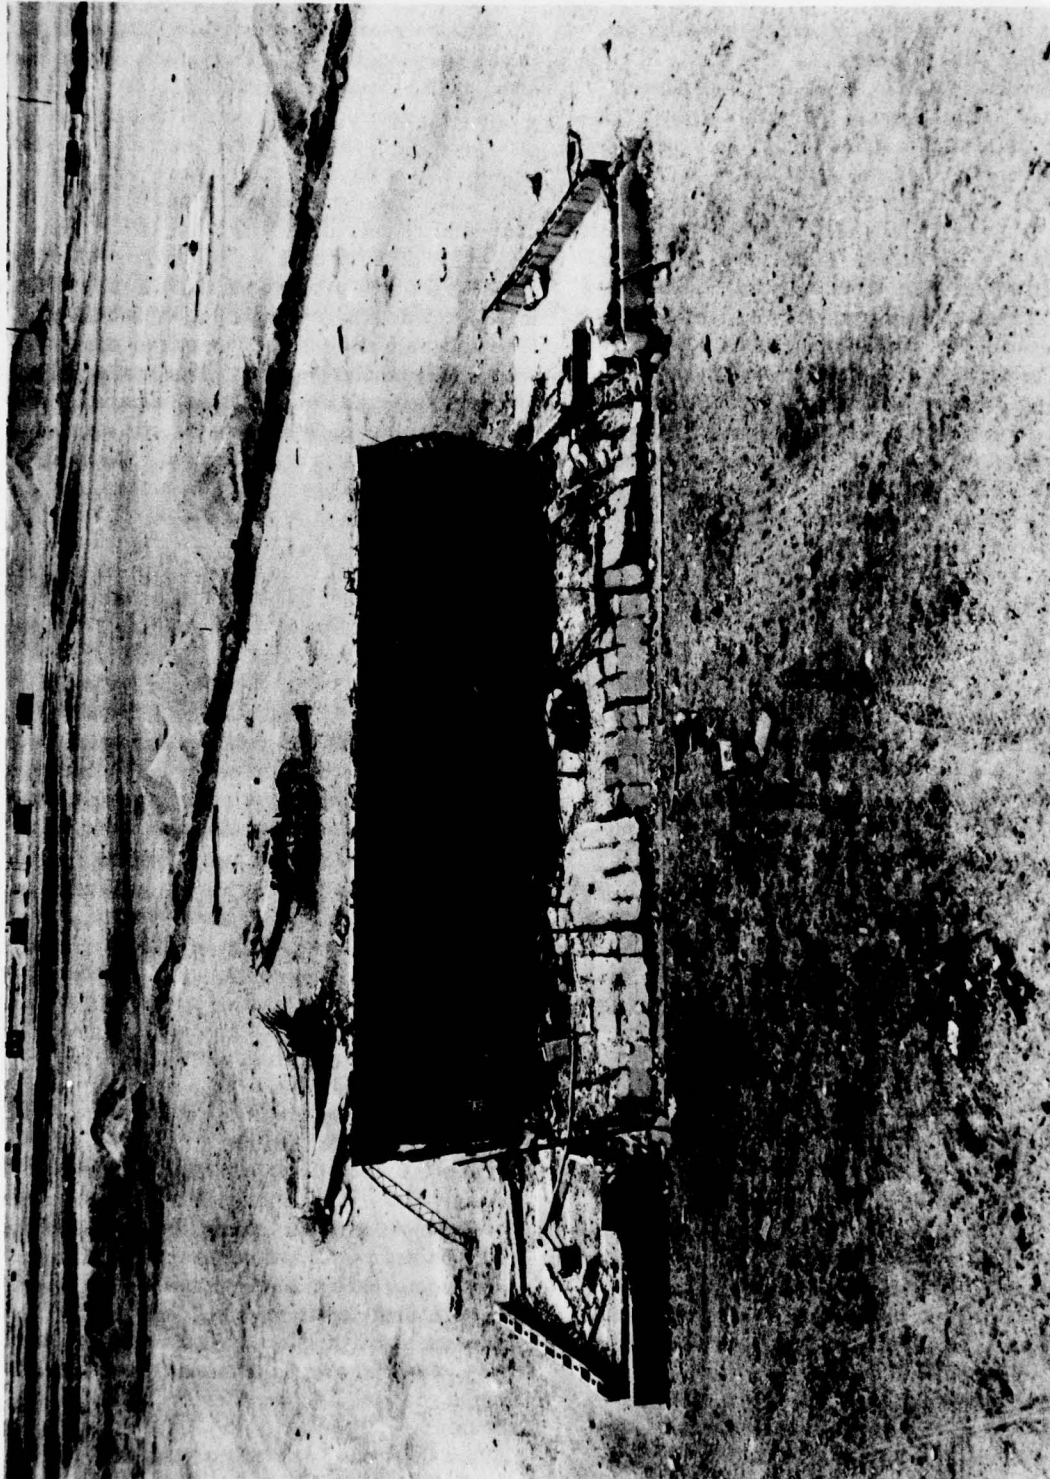
Fig. 6.47 Edge Row of Roof Cells Still Attached to Each End Wall, Structure 3.2.3b

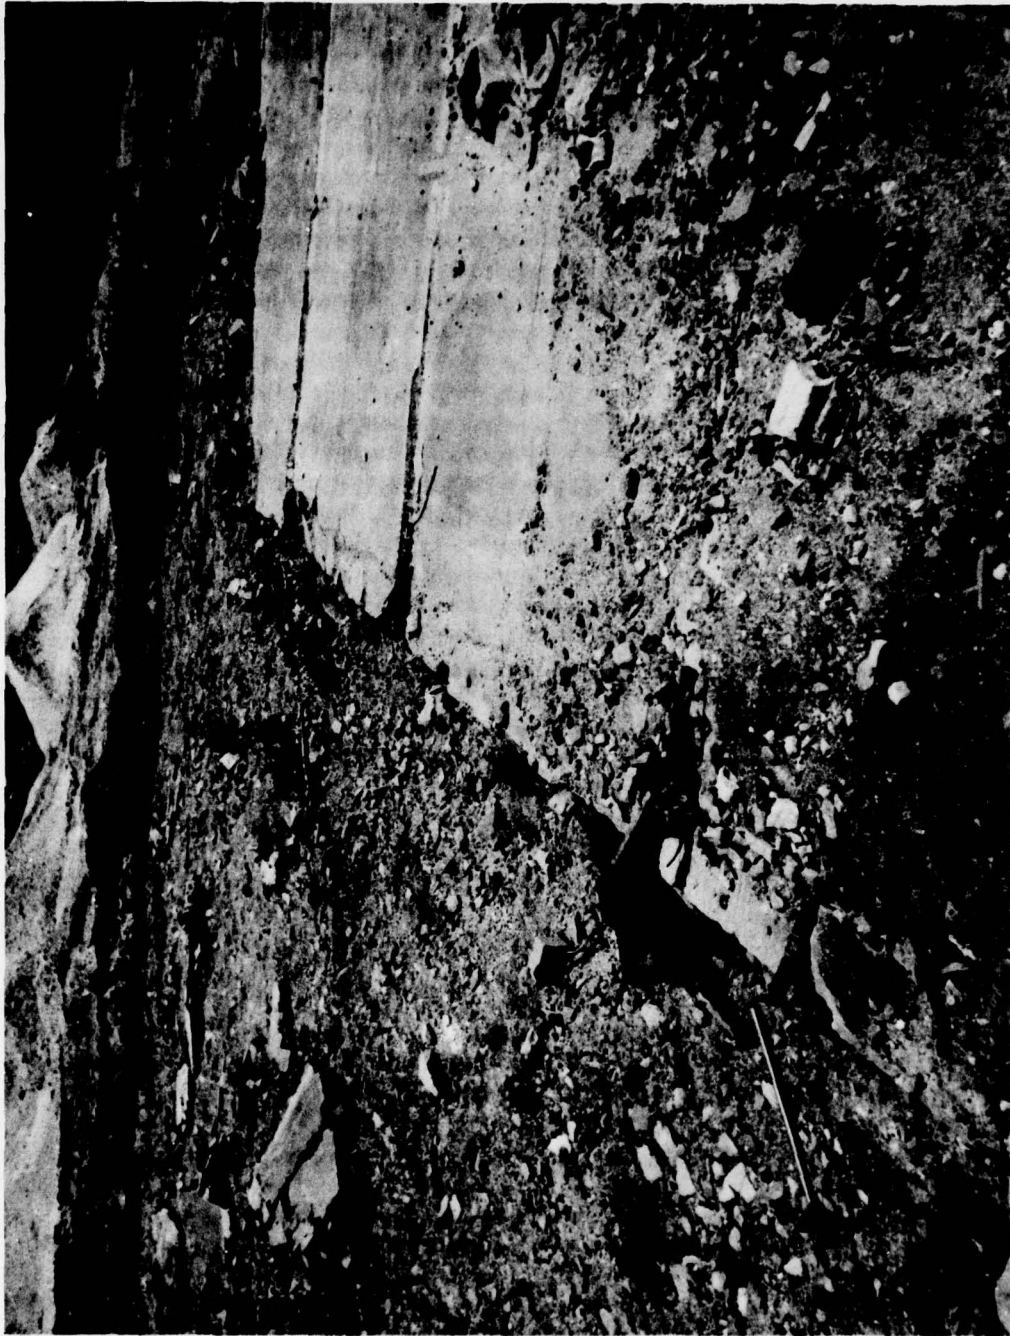
Fig. 6.48 Top Edge of Rear Wall of Structure 3.2.3a. Failure of the weld at the top ends of the chord bars of the wall truss can be clearly seen.
